**EVALUATING THE PERFORMANCE OF PLAIN AND
BLENDED CEMENT CONCRETES UNDER MARINE
ENVIRONMENT IN THE ARABIAN GULF**

A Thesis Presented to the
DEANSHIP OF GRADUATE STUDIES

KING FAHD UNIVERSITY OF PETROLEUM & MINERALS

MAY 2014

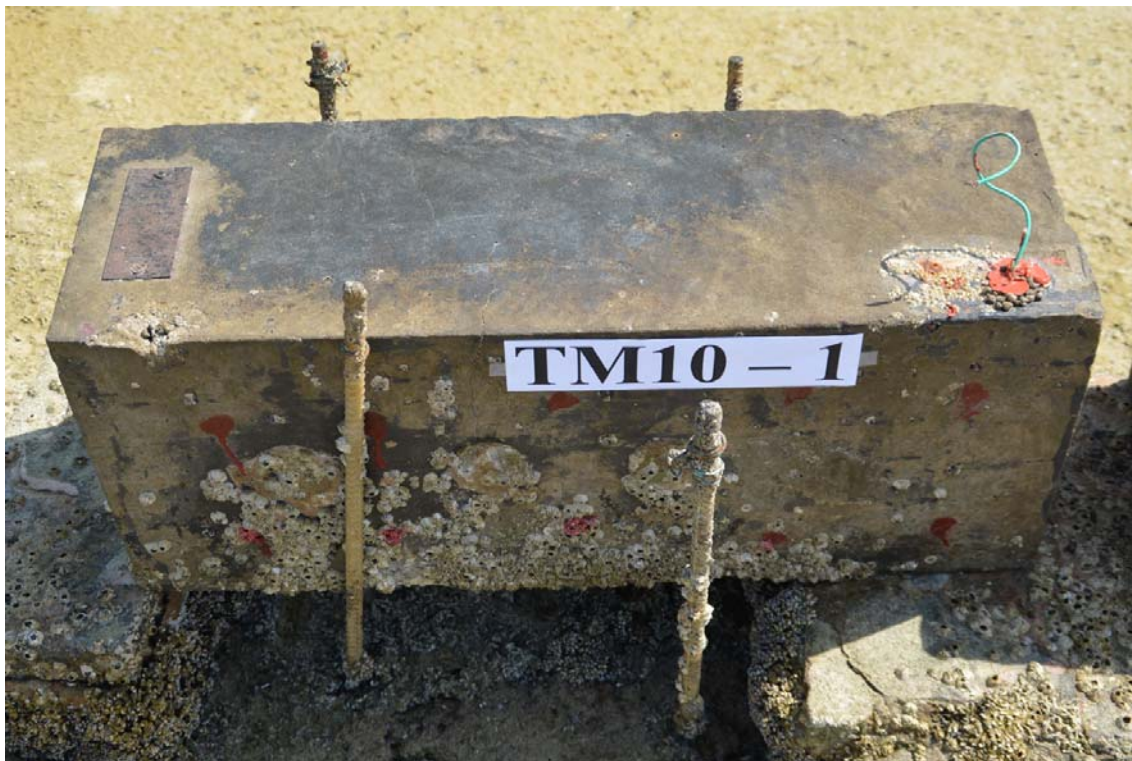
No noticeable deterioration was noted in the beam specimens exposed in the tidal zone for 10 years, except for mix TM20. However, deposition of algae was noticed in almost all the specimens due to which the color of concrete changed to greenish black to black in some cases. Minor to major deposits of shells were noticed on the specimens with high density of shells found on the side facing the sea. Shell deposits were not noted on the top face of the beam specimens. Moderate deterioration was noted at the corners of the beams of mix TM20. A typical photograph of a beam specimen is shown in Figure 4.1.

Figure 4.1. Typical photograph of a beam specimen in the tidal zone.

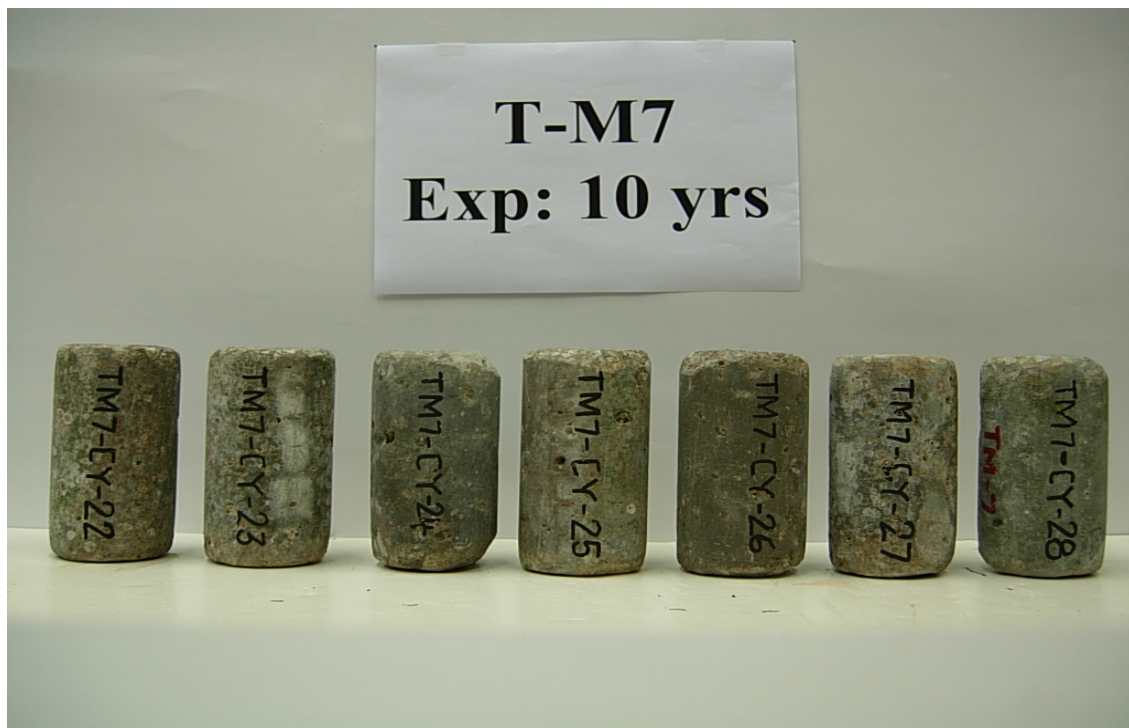
Figure 4.2. Typical concrete cylindrical specimen exposed to tidal zone.

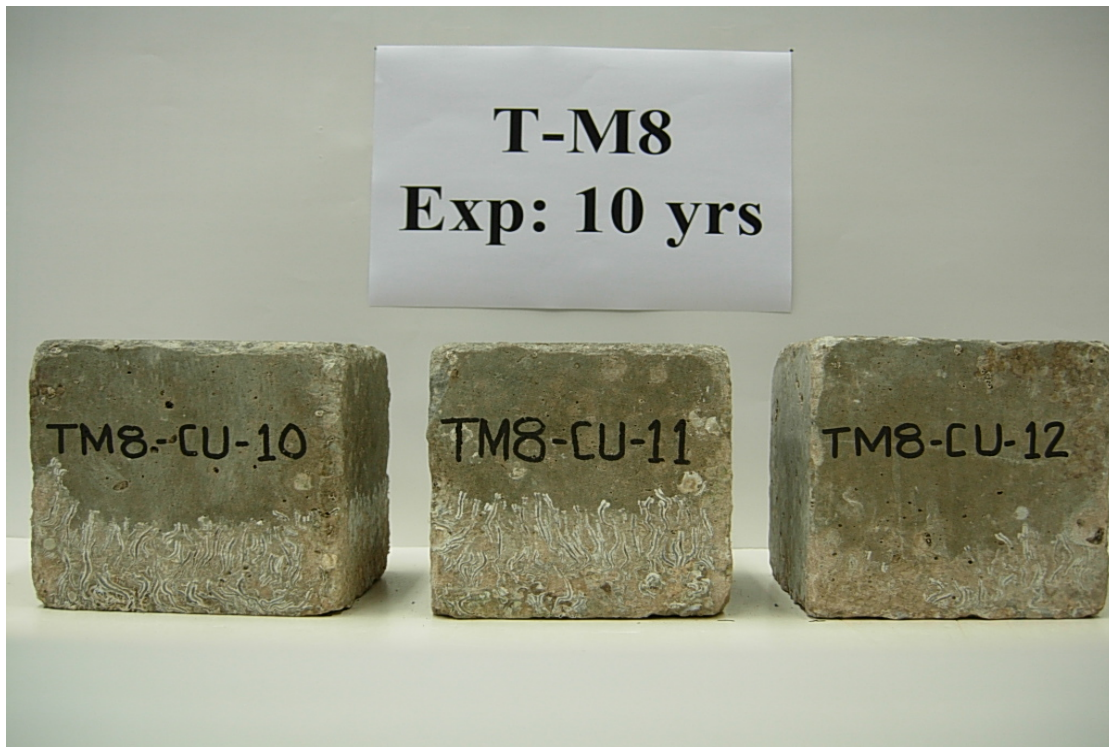
There was moderate deterioration of cube specimens of mix TM20 and TM8. Minor to major deposits of shells were noticed on the surface of the specimen. The corners of some of the specimens were broken due to rolling action by the sea water. Greenish deposits of algae and probably oil were also observed. This may have caused discoloration of the specimen. Photograph of a typical specimen is shown in Figure 4.3.

Figure 4.3. Typical cube concrete specimen exposed to the tidal zone.

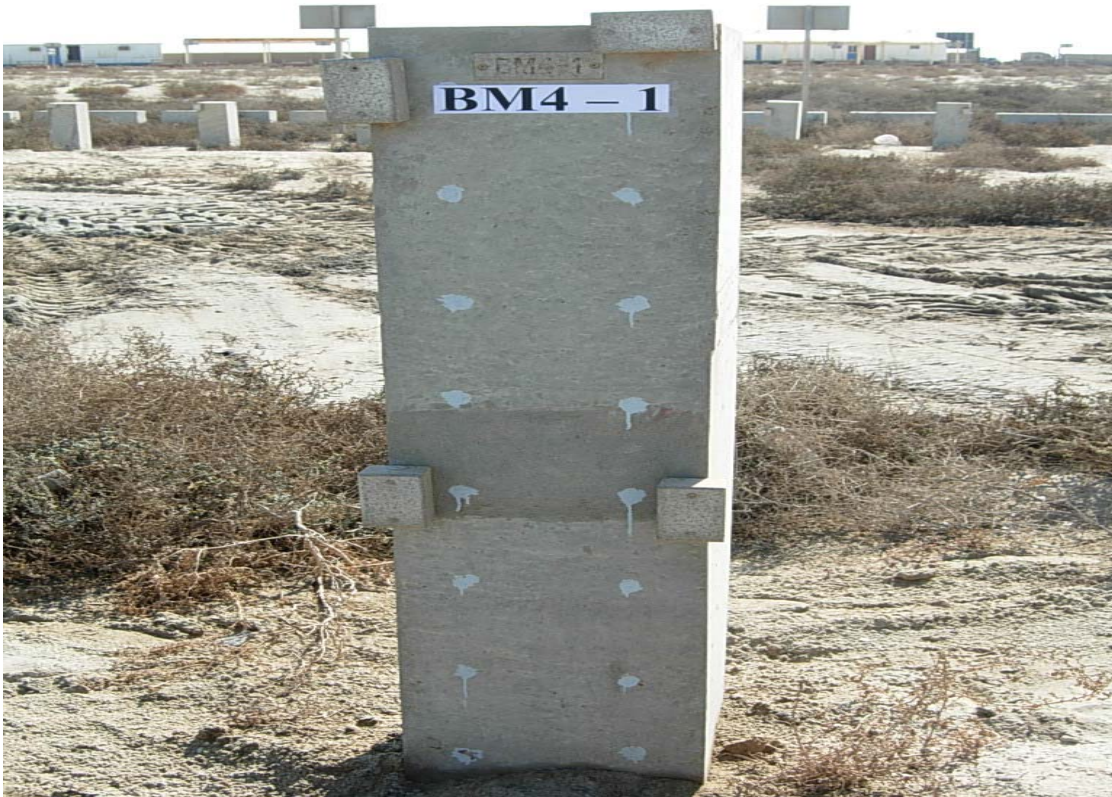
Figure 4.54. Photograph of a column specimen in the partially buried zone.

There was no major noticeable deterioration in the columns exposed to the partially buried zone for 10 years. Fine shrinkage cracks were noticed in the finished mortar on the mid section of the columns. In the specimen with mixes BM3, BM7, BM15, and BM18, weathering of concrete was noted at the interface, possibly due to sulfate attack mostly towards the sea side face. Also, aggregate was found to be exposed in the specimen made of mix BM 17 at the interface. A typical photograph of a partially buried column is shown in Figure 4.54.

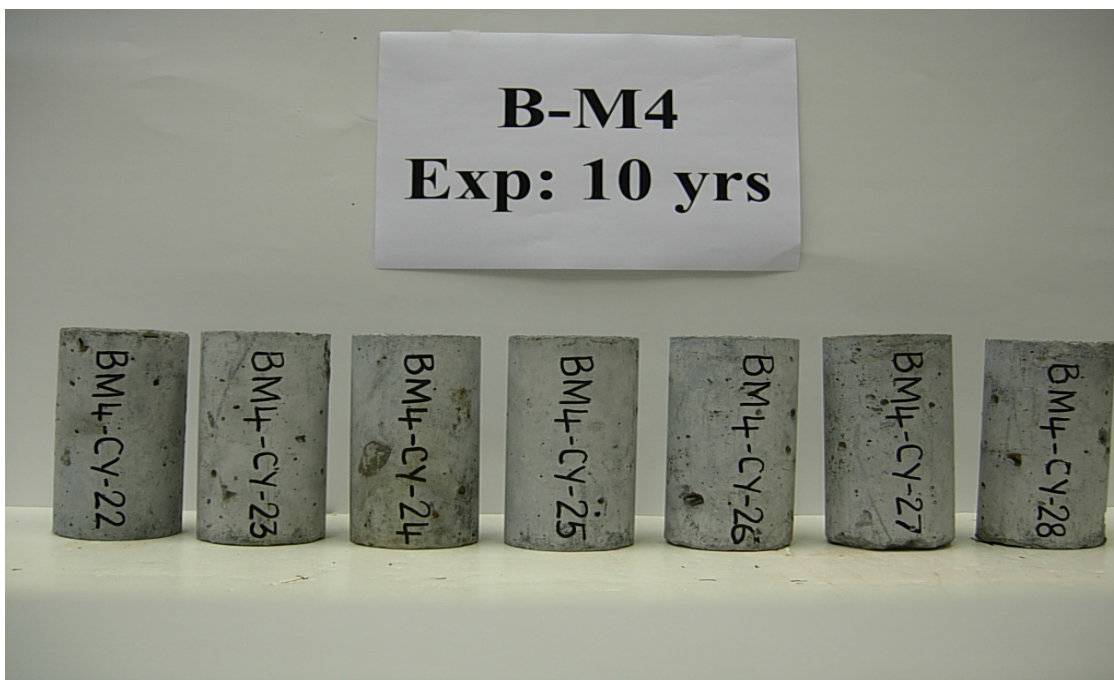
Figure 4.55. Concrete cylindrical specimens exposed to below ground conditions for 10 years.

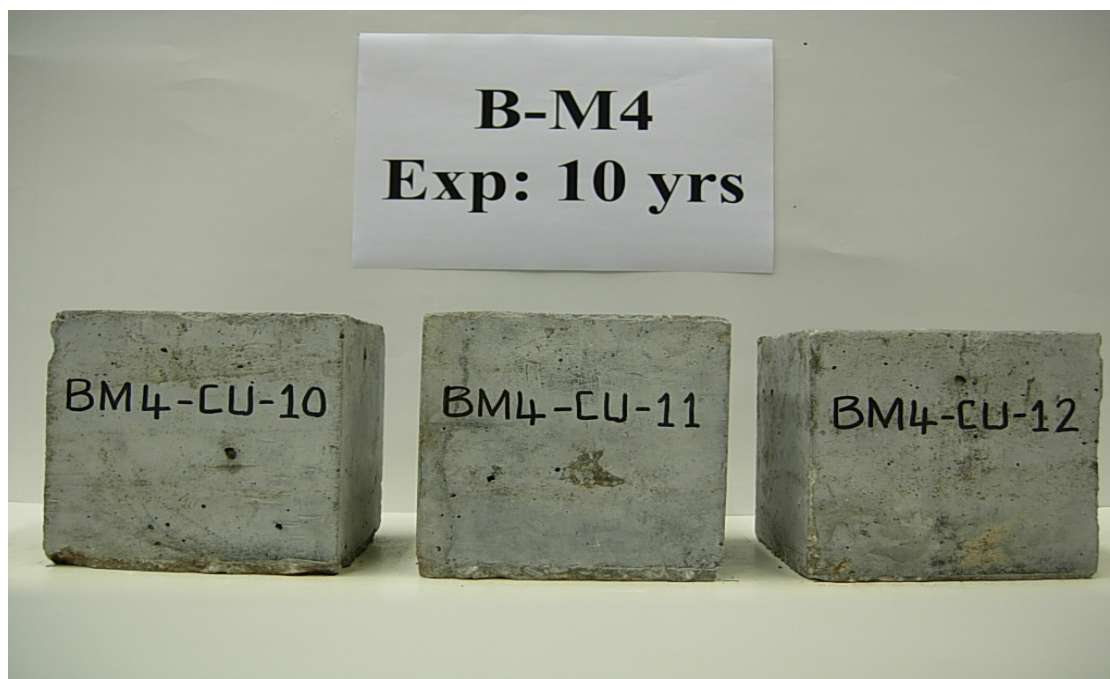
Figure 4.56. Cube concrete specimens exposed to below ground conditions for 10 years.

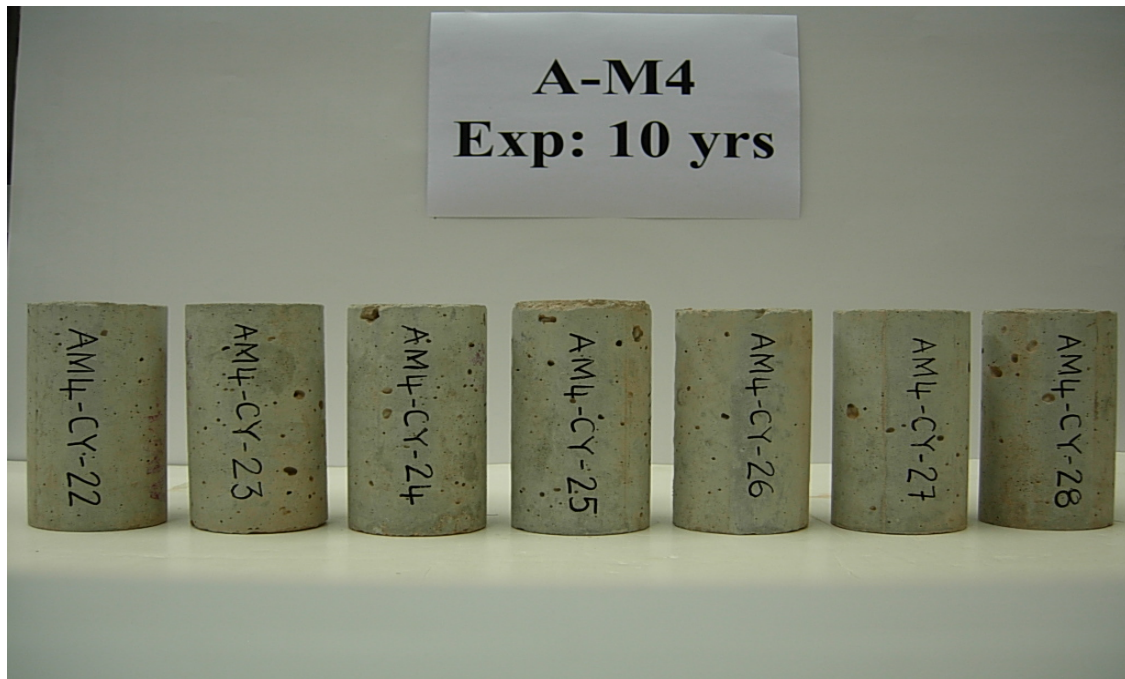
Figure 4.96. Cylindrical concrete specimens exposed to above ground conditions for 10 years.

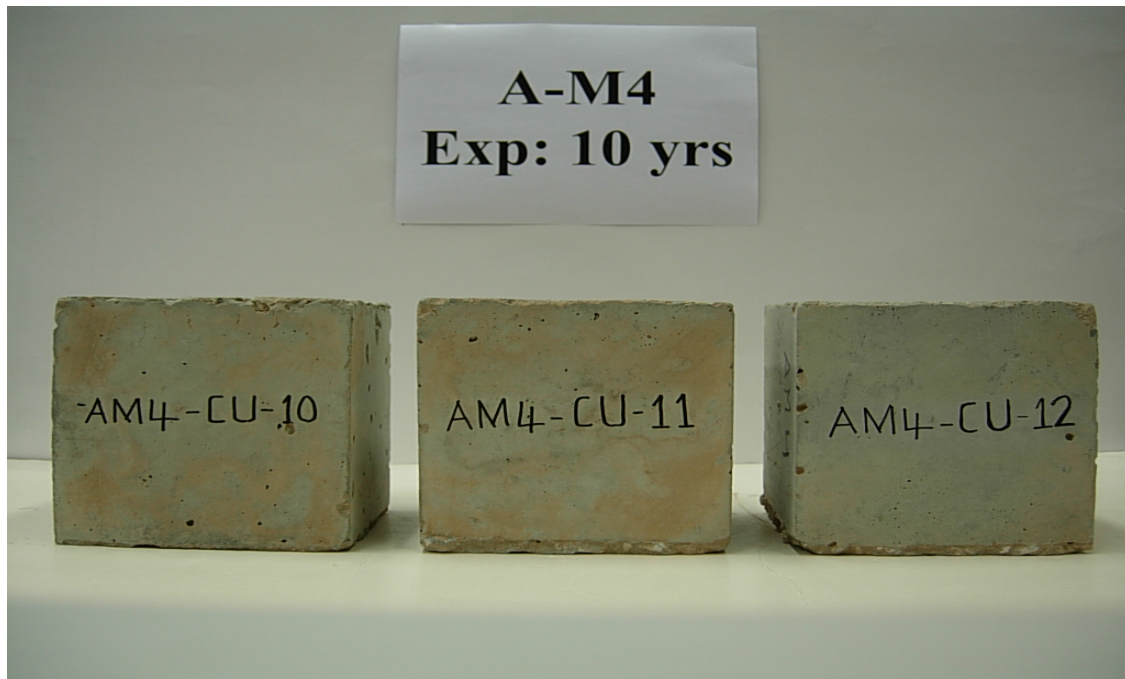
Deterioration was not noted in cubes specimen exposed the above ground conditions. No change in color was noted in any of the specimens. Figure 4.97 shows typical photograph of a specimen in this zone.

Figure 4.97. Cube specimens exposed to above ground conditions for 10 years.
